Customer:	Email:	Date: 12-11-04
Address:	Phone (h):	County: Hennepin
City/State/Zip: Edina/MN/55435	Phone (c):	Hudson:

PROBLEM

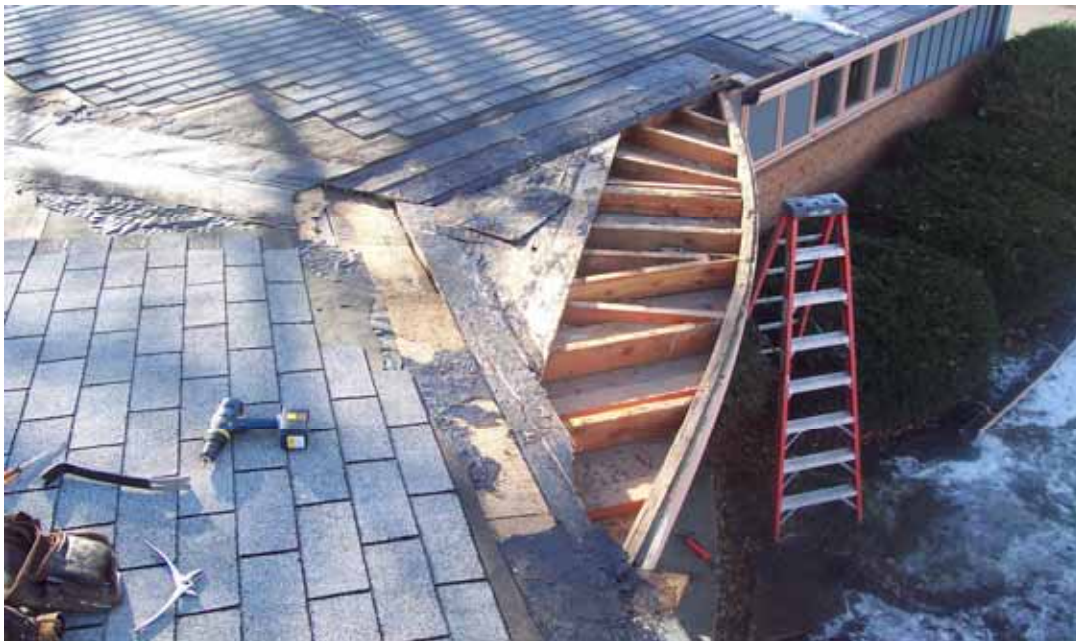
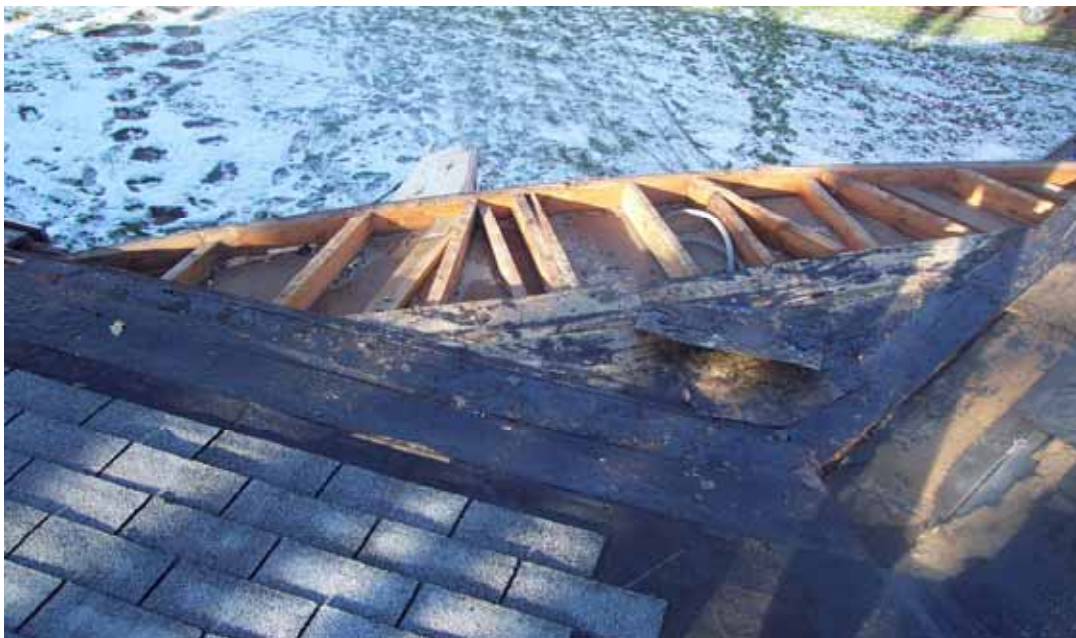
Lack of roof pitch combined with screw holes in rubber portion of roof from faulty gutter installation caused water damage to roof sheathing and fiberboard.

Rebuilt the damaged portion of the roof with 1/2" green treated decking, water resistant high density fiberboard, GRACE ultra ice & water shield, 60 mil rubber membrane and 4" drip edging with P & L flashing. Re-installed the gutters on outside fascia to prevent penetration through rubber portion of roof.
