PROBLEM

SOLUTION

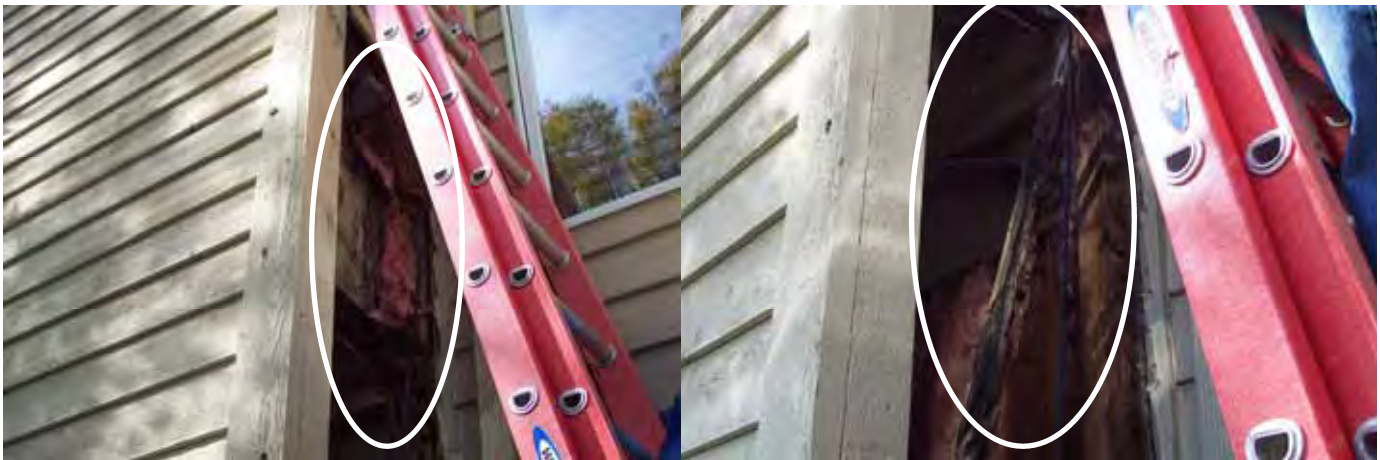
Chimney box damage was caused by excessive water overflow from the gutter and into the chimney box. A lack of water intrusion prevention to include proper gutter flashing resulted in extensive water damage to the exterior siding, interior drywall, sheathing and structural lumber.

Removed all water damaged materials to include structural lumber, mold invested drywall & insulation and dry rot exterior sheathing, corner boards and siding. Installed appropriate flashing and incorporate water damage prevention techniques to include Tyvek house wrap on chimney box exterior.

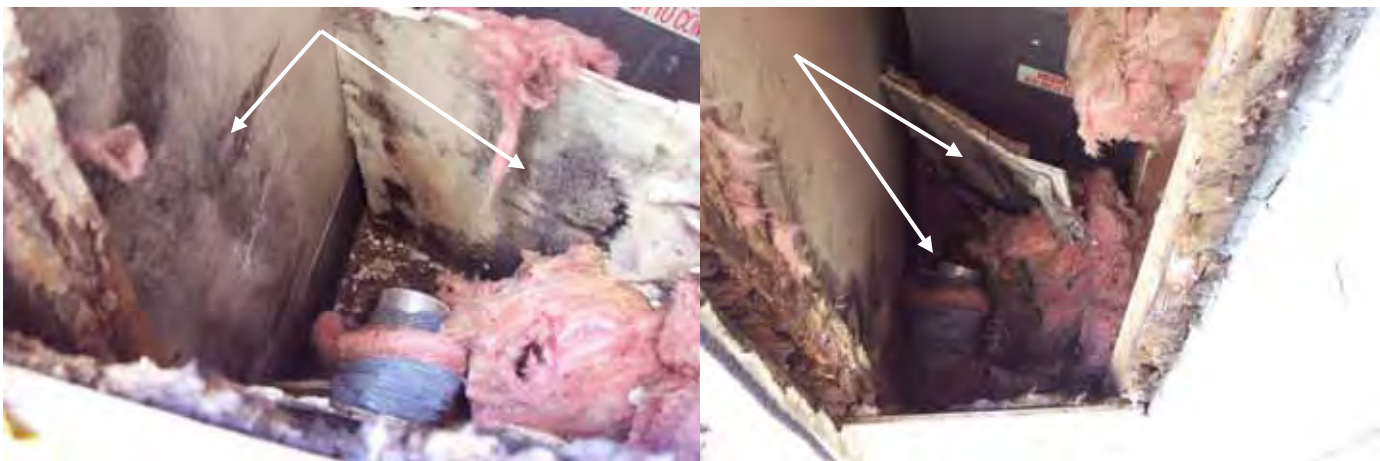
Excessive mold found throughout the chimney fire box on interior drywall & insulation along with the vent ducting from lower fireplace disconnected after interior drywall fell due to water saturation.
